McWilliams Electric Co., Inc.
Infrared Electrical Scan Division

123 Main St.
Chicago, Illinois 60606
Infrared Electrical Inspection Report
Prepared by McWilliams Electric

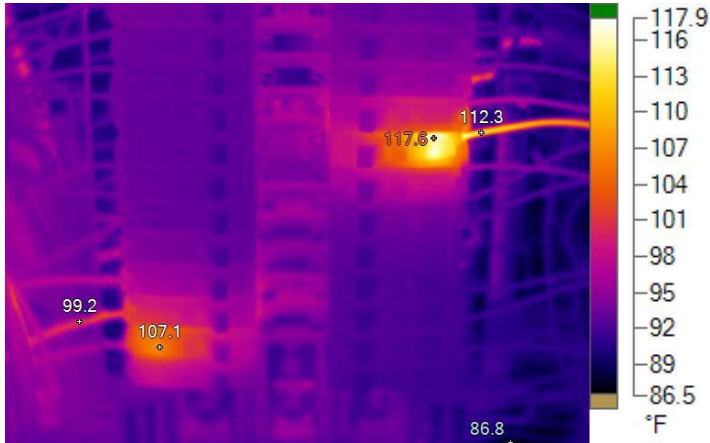
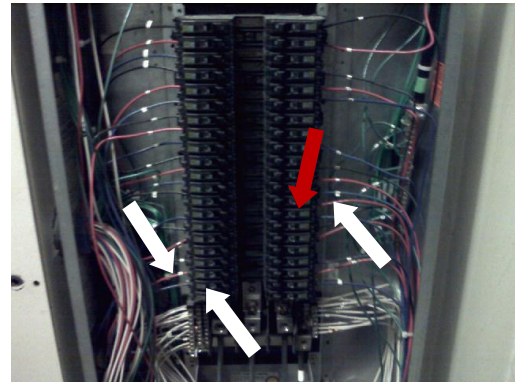
425 - Panel RP-2A - Bottom.IS2

| Information on Problem | | |
|---|---|---|
| 30.8°F | Minor | When Convenient |

| Cause & Recommendation | |
|---|--|
| Overloaded breaker/Loose or dirty connection | Check breaker load. Clean and tighten connection. |

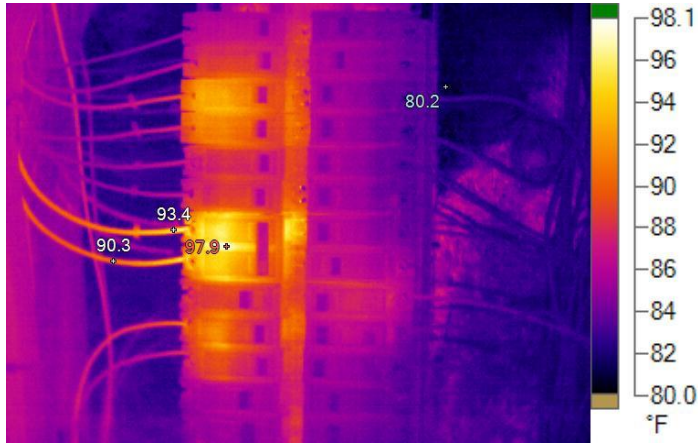
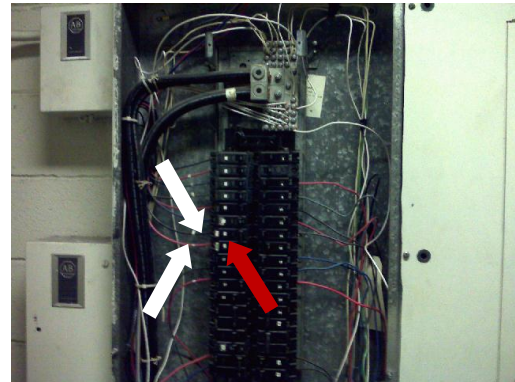
428 - Panel RP-1 - Breakers.IS2

| Information on Problem | | |
|---|---|---|
| 17.7°F | Minor | When Convenient |

| Cause & Recommendation | |
|---|--|
| Overloaded breaker/Loose or dirty connection | Check breaker load. Clean and tighten connections |

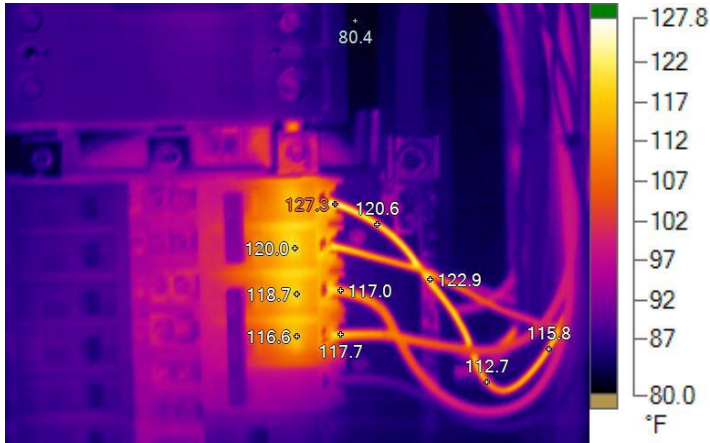
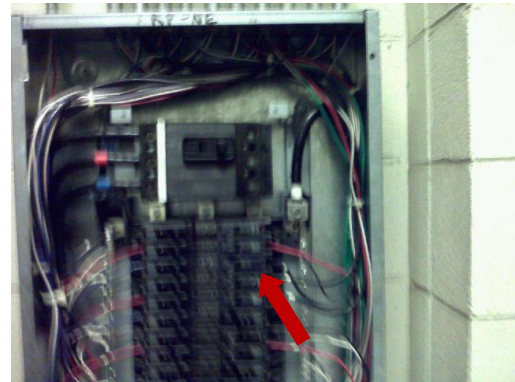
433 - Panel RP-NE - Top.IS2

| 46.9°F | Minor | When Convenient |

| Overloaded breaker/Loose or dirty connection | Check breaker load. Clean and tighten connections |

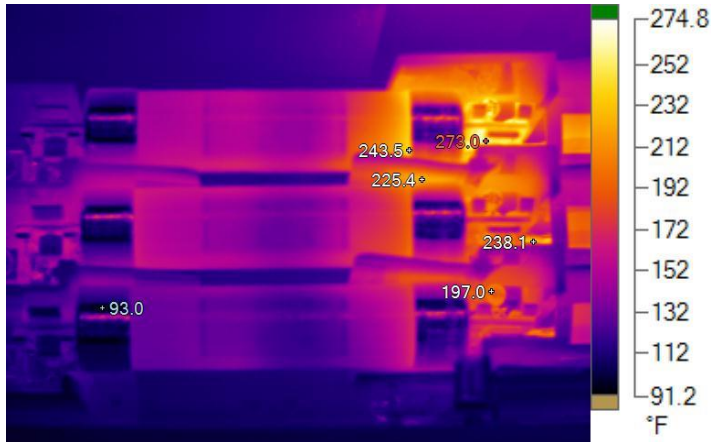
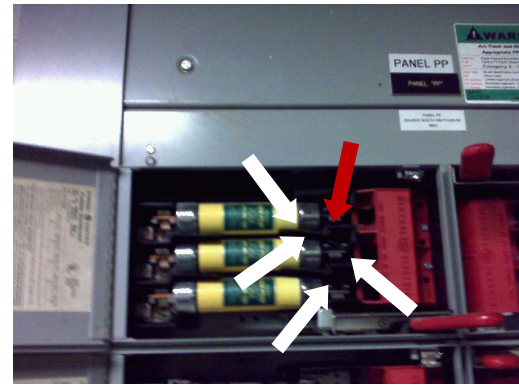
453 - 100A Switch - AHU-1.IS2

| Information on Problem | | |
|---|---|---|
| 180.0°F | Major | REPAIR IMMEDIATELY |

| Cause & Recommendation | |
|---|--|
| Loose or dirty connections | Remove & clean fuses. Tighten connections |

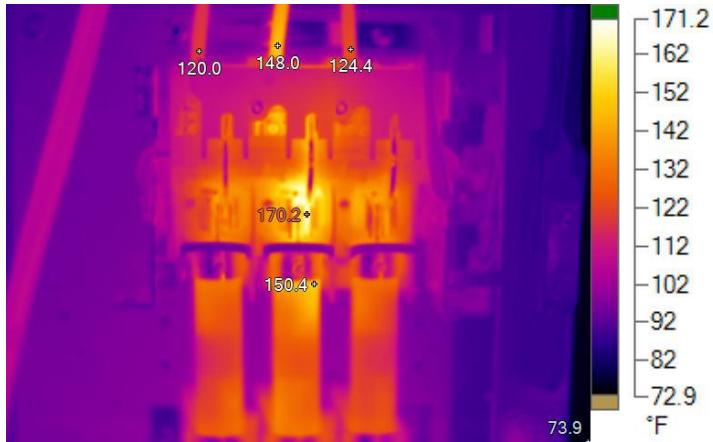
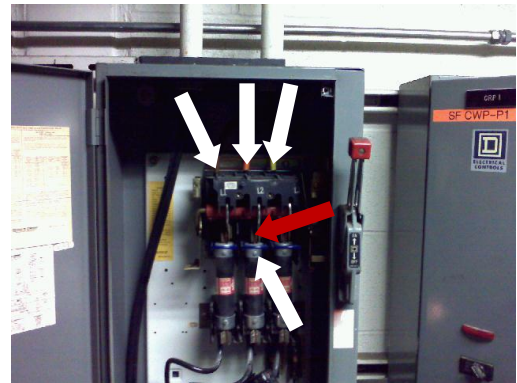
469 - AUH-13.IS2

| Information on Problem | | |
|---|---|---|
| 96.3°F | Major | REPAIR IMMEDIATELY |

| Cause & Recommendation | |
|---|--|
| Overloaded fuses/ Loose or dirty connections | Check load. Remove and clean fuses & reinstall. Tighten all connections |

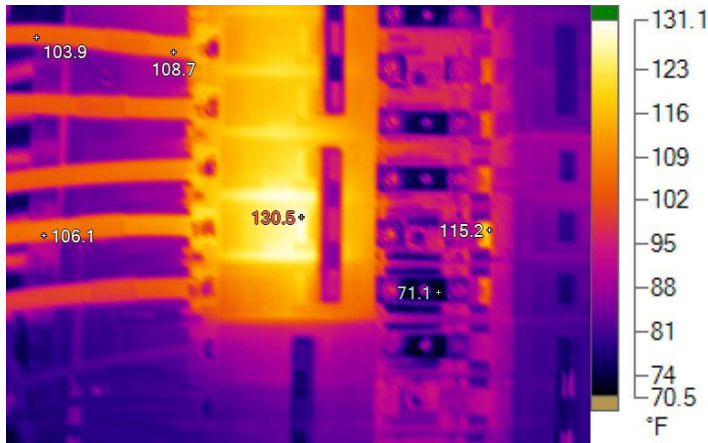
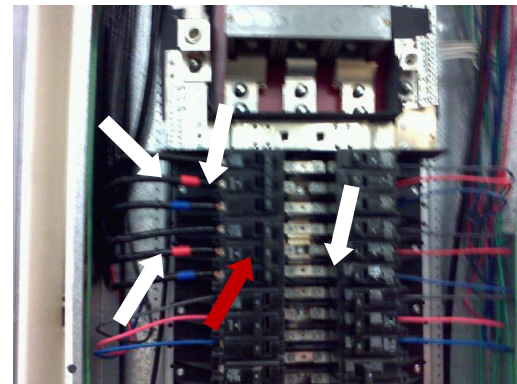
507 - Panel EQP-9A Breakers 1,3,5 and 7,9,11.IS2

| Information on Problem | | |
|---|---|---|
| 59.4°F | Minor | When Convenient |

| Cause & Recommendation | |
|---|---|
| Overloaded breaker/Loose or dirty connection | Check load. Clean and tighten connections. |

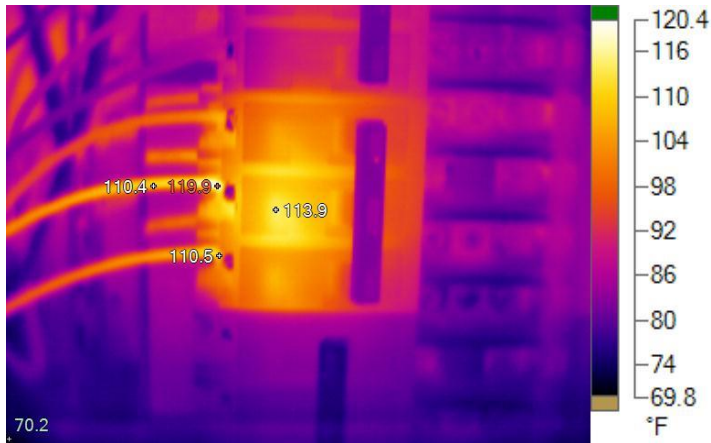
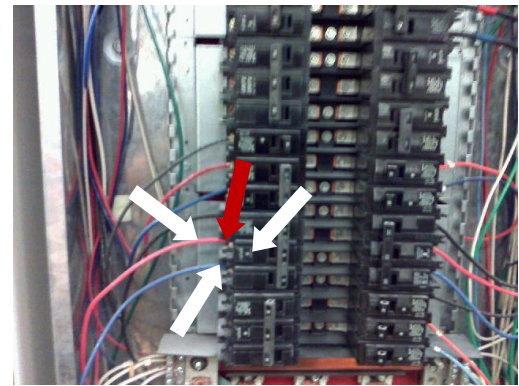
508 - Panel EQP-4 - Breaker 31,33,35.IS2

| Information on Problem | | |
|---|---|---|
| 49.7°F | Minor | When Convenient |

| Cause & Recommendation | |
|---|---|
| Overloaded breaker/Loose or dirty connection | Check load. Clean and tighten connections. |
